### *Library Construction Report*

This report covers the period up to August 7, 2019 .

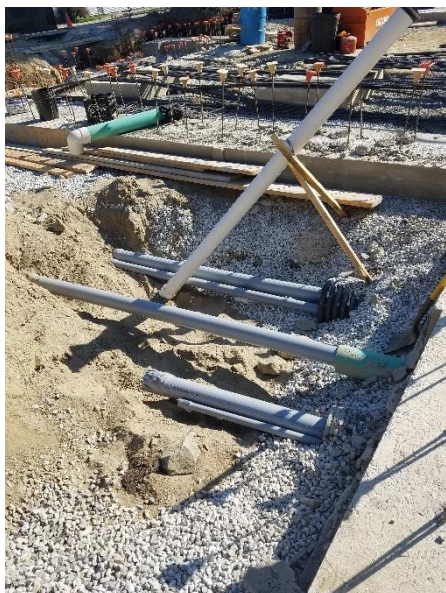
This photo shows the work began by the electrical contractors on running the conduit underground for electrical and mechanical connections to the building prior to pouring the floor.

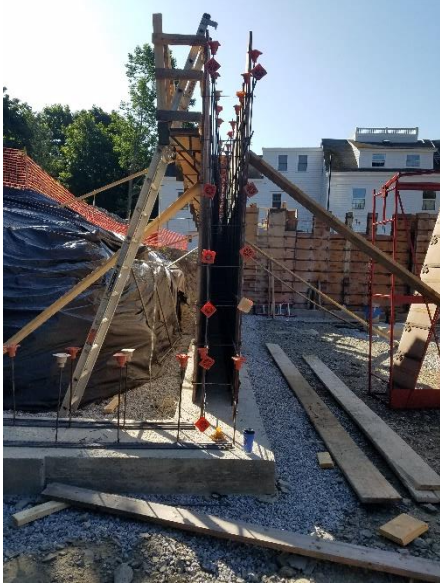
Over the last week, the first of the concrete forms on the stream side of building were installed, as soon as the footings were completed. This first area is the area that is the unfinished “expansion” area of the building. These forms have a very intricate pattern of re-bar constructed inside of the forms. The number one question being asked about the forms is about the spaces at the top of the forms. These will get filled in as each form is staggered intentionally.

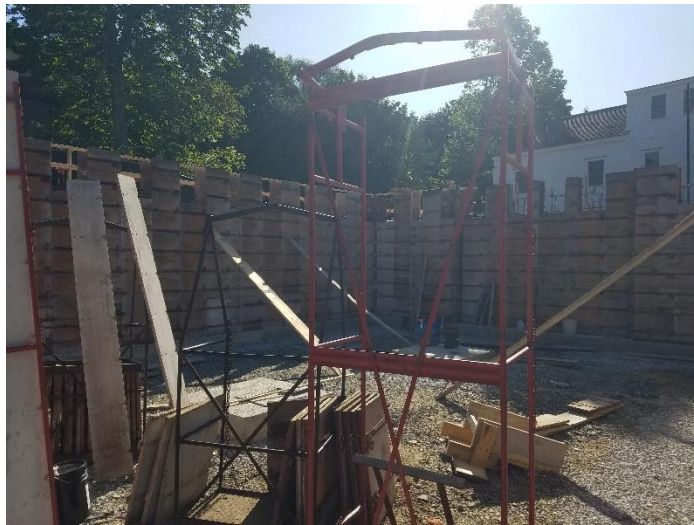
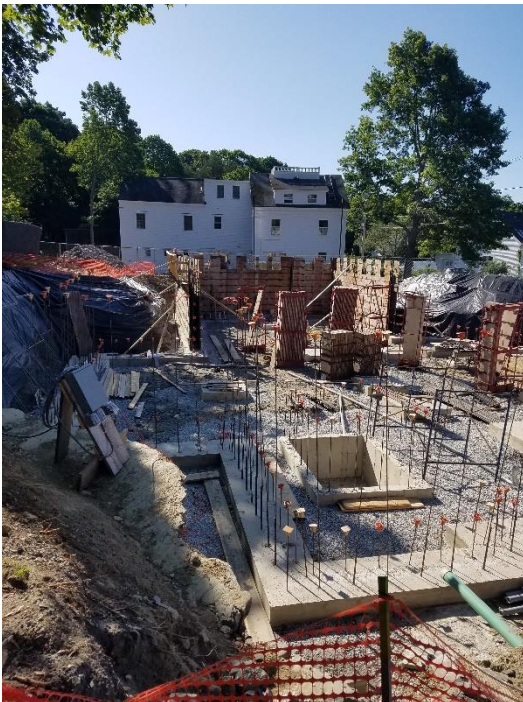
Pictured here is a view of the north end of the site showing the wall sections for the first pour on the stream side of the site.

You can see the elevator pit as well as the taller parts of the re-bar that run from the footings to the top of the finished wall.

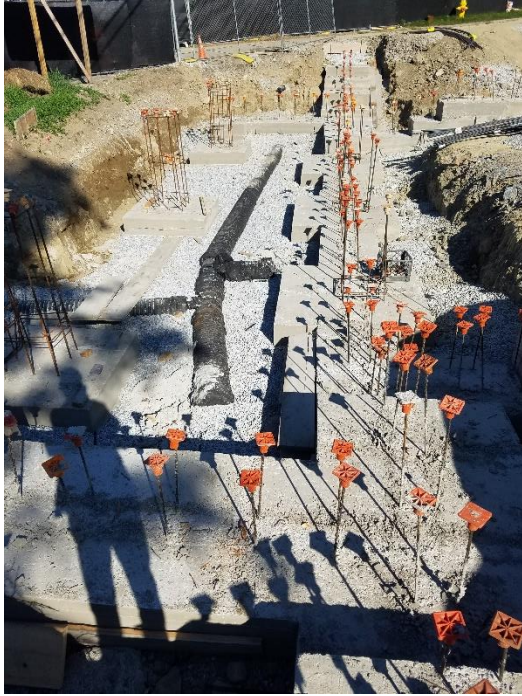
Pictured here is the finished footings and rebar installation for the Russel Ave side of the building as well as the footings for the columns that will support the deck on the front of the building.

Because of the complexity of this and the connection to the building of the deck. This area was the subject of a great deal of scrutiny over the last few weeks. The team agreed on the best approach of getting this done in the most cost-effective way while providing the best possible building envelope to prevent water infiltration into the building
